Operation TEAPOT

Project 31.2

DAMAGE TO COMMERCIAL AND INDUSTRIAL BUILDINGS
EXPOSED TO NUCLEAR EFFECTS

Bruce G. Johnston

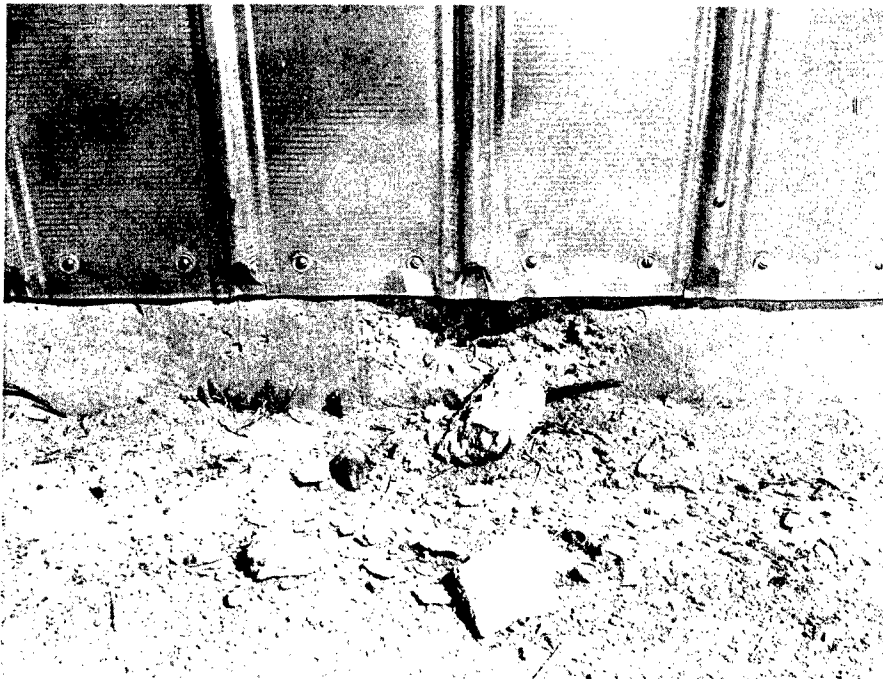
Fig. 2.47—South side of east interior column footing of Reynolds-Butler Building 31.2-a2 after planned test.

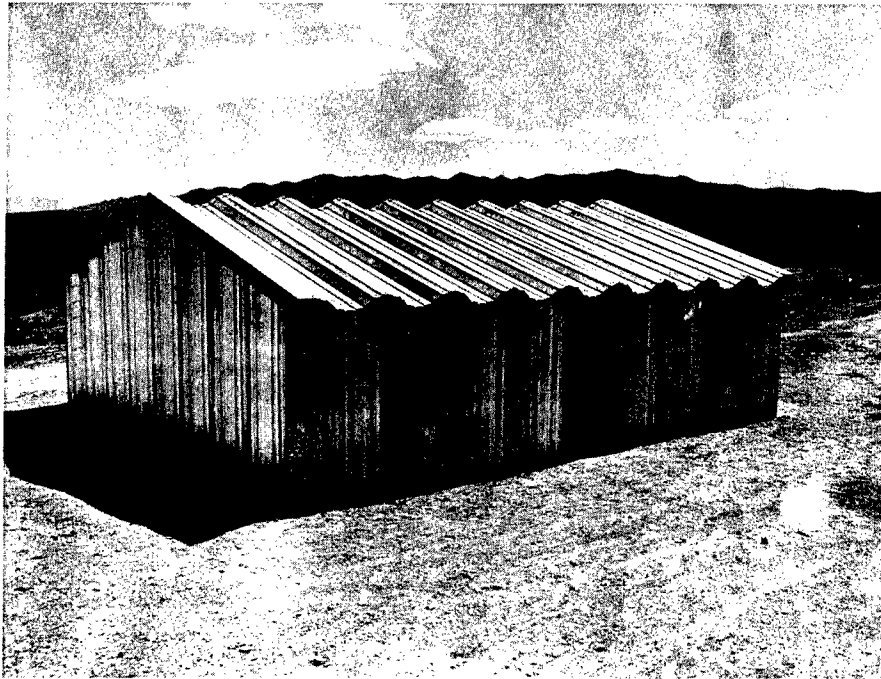
Fig. 2.50 — East end and north side of Behlen Building 31.2-b2 after planned test.

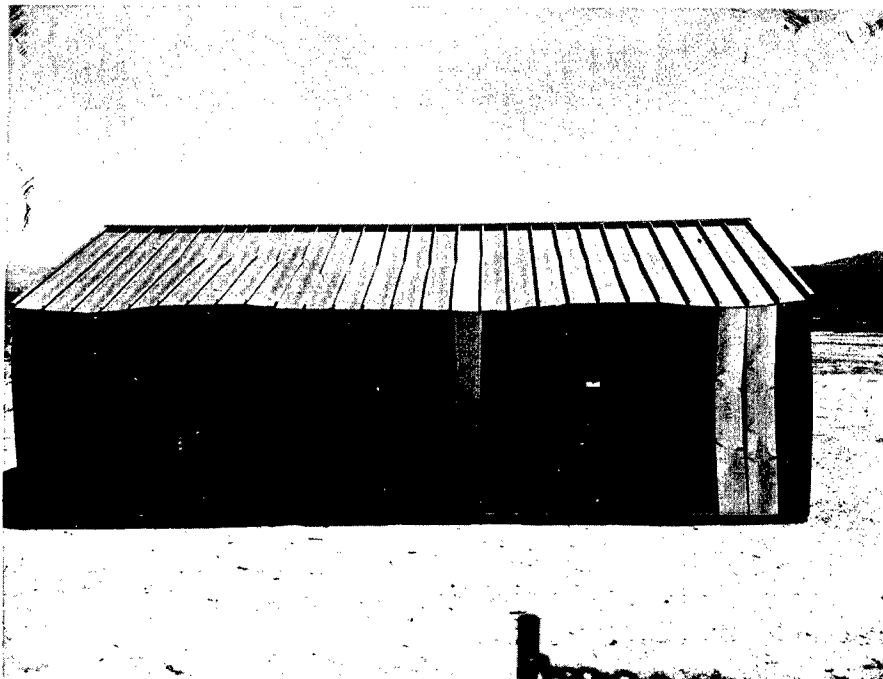
Fig. 2.51 — North side of Armco Building 31.2-d2 after planned test.
